Cutrite 3398 Case Study #2

Reduced scrap and increased insert life

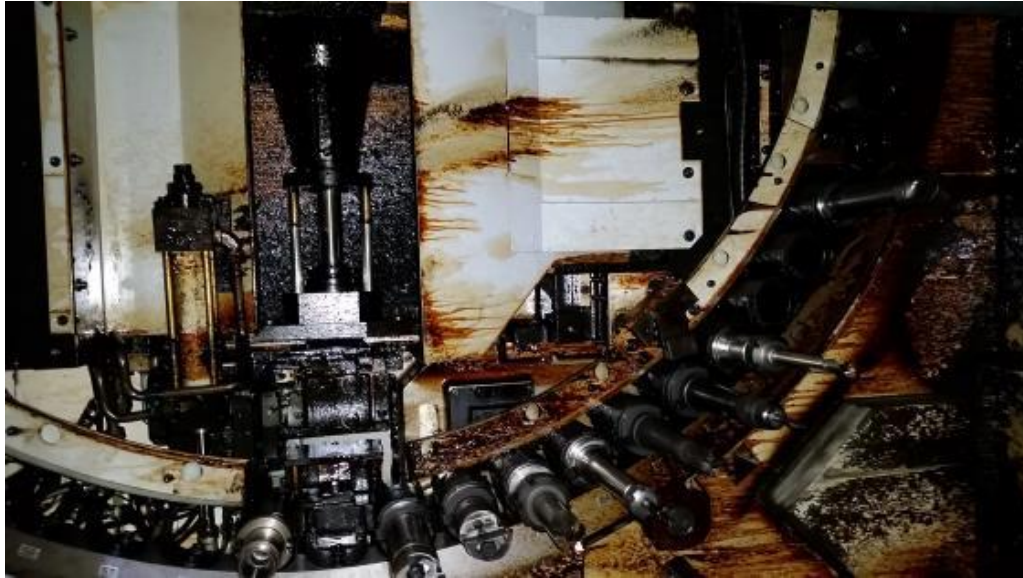
CNC 20 running current semi-synthetic

The ATC units were cleaned prior to the start of the trial.

These images are after 8 months of running the machines 2 shifts for 5 days per week

- Improved insert life during the trial by 10%. After switching all the machines to Cutrite 3398 average tool life increased by over 12%
- Misalignment due to dirty tool holders was eliminated. (see pictures below)
- Reduced coolant cost by 18%, due to reduced consumption
- Eliminated all odor complaints
- Eliminated all rust issues on equipment and in-process parts
- The equipment was clean. No greasy deposits or rust
- Tramp oils are now able to be skimmed off the fluid
